Thermbond is a registered trademark of Stellar Materials Incorporated, Boca Raton, FL, USA. Stellar Canada Inc. is an independent distributor of Stellar Materials Incorporated.

09/09

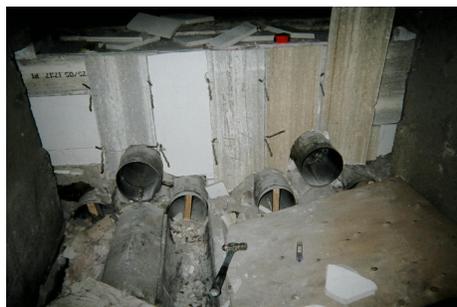
End Wall Reline with Thermbond Formula 6L in a wood waste feed furnace. Insulating board installed ready for Thermbond hot face.

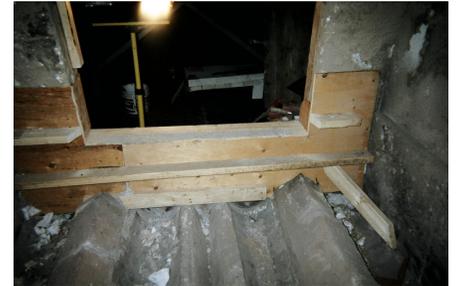
Thermbond Formula 6L formed and cast in the discharge end wall.

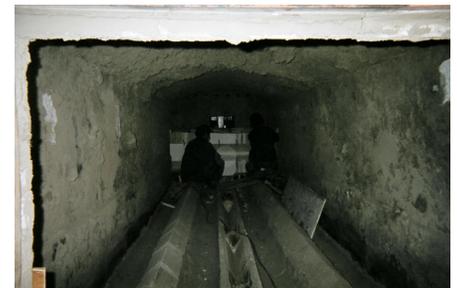
Looking from the discharge end towards the burning zone end wall.

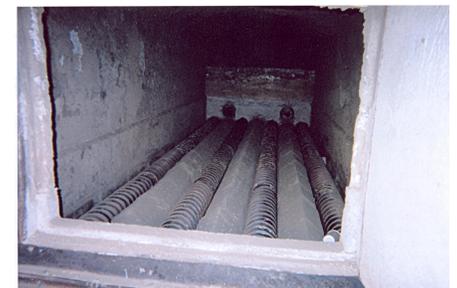
The completed repairs with floor augers replaced.
